737

Service Bulletin

Number: 737-57-1320
Original Issue: October 07, 2016
ATA System: 5700

SUBJECT: WINGS - Trailing Edge - Tank Access Door - Replacement

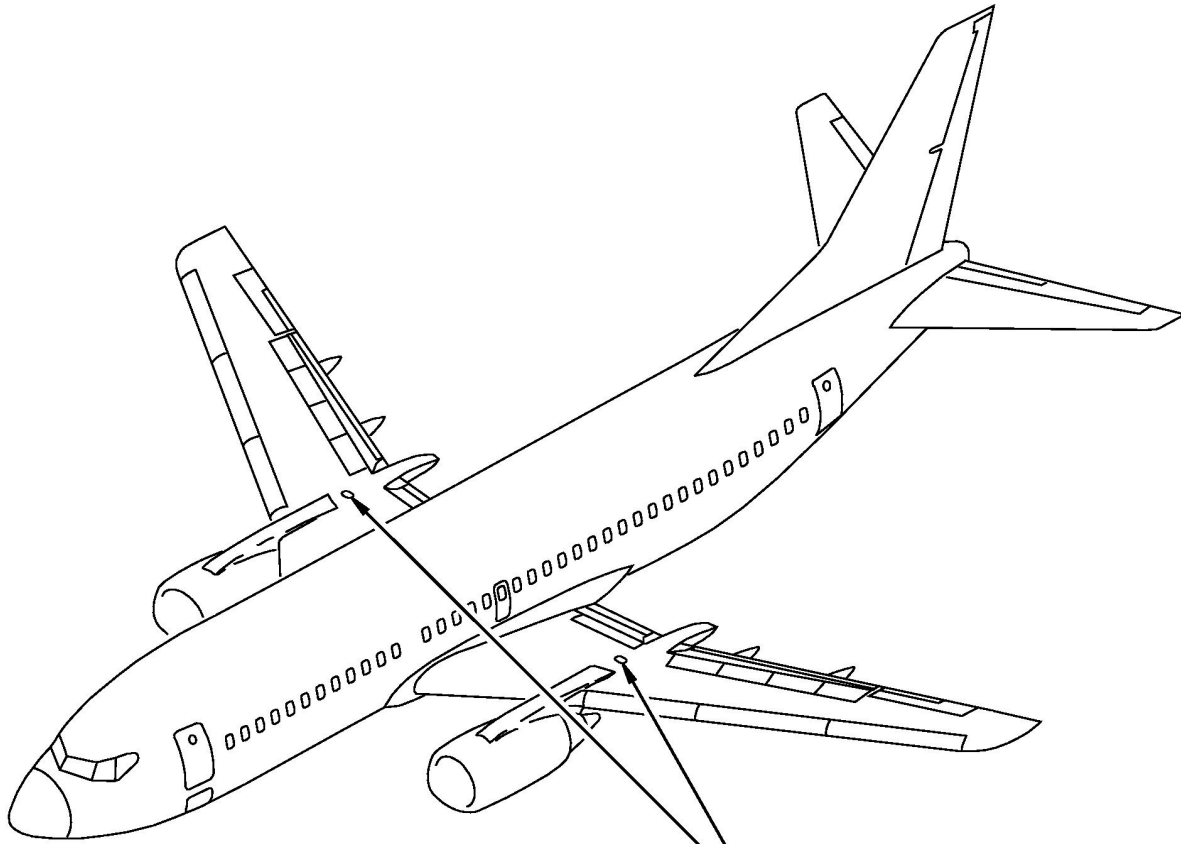
2259029

A review by Boeing of the drawings for the tank access door at Wing Buttock Line (WBL) 191.00 has shown that it did not have an engineered ground path with the mating wing structure. The current installation could become a potential source of ignition in the event of a lightning strike. This service bulletin replaces the tank access door with a new installation that has two engineered ground paths between the new door assembly and the mating wing structure. The primary ground path is created by installing a new wire mesh gasket between bare metal surfaces on the door assembly and the mating wing structure. The door assembly has been made thicker to further resist the high current caused by lightning, and features a bonded phenolic ring to electrically isolate the access door from the part of the mating wing structure that physically contacts fuel and fuel vapors. The secondary ground path is created by using a new conductive bolt installation. The nutplates that attach to the door assembly bolts are also cap sealed to prevent possible sparks from igniting the fuel vapors. If the changes in this service bulletin are not made, there is an increased risk of ignition and subsequent fuel tank explosion if there is a lightning strike.

REPLACE THE EXISTING TANK
ACCESS DOORS, MAKE CHANGES TO
THE MATING DOUBLER SURFACE,
AND MAKE SURE THE RESISTANCE IS
0.0025 ohm OR LESS.

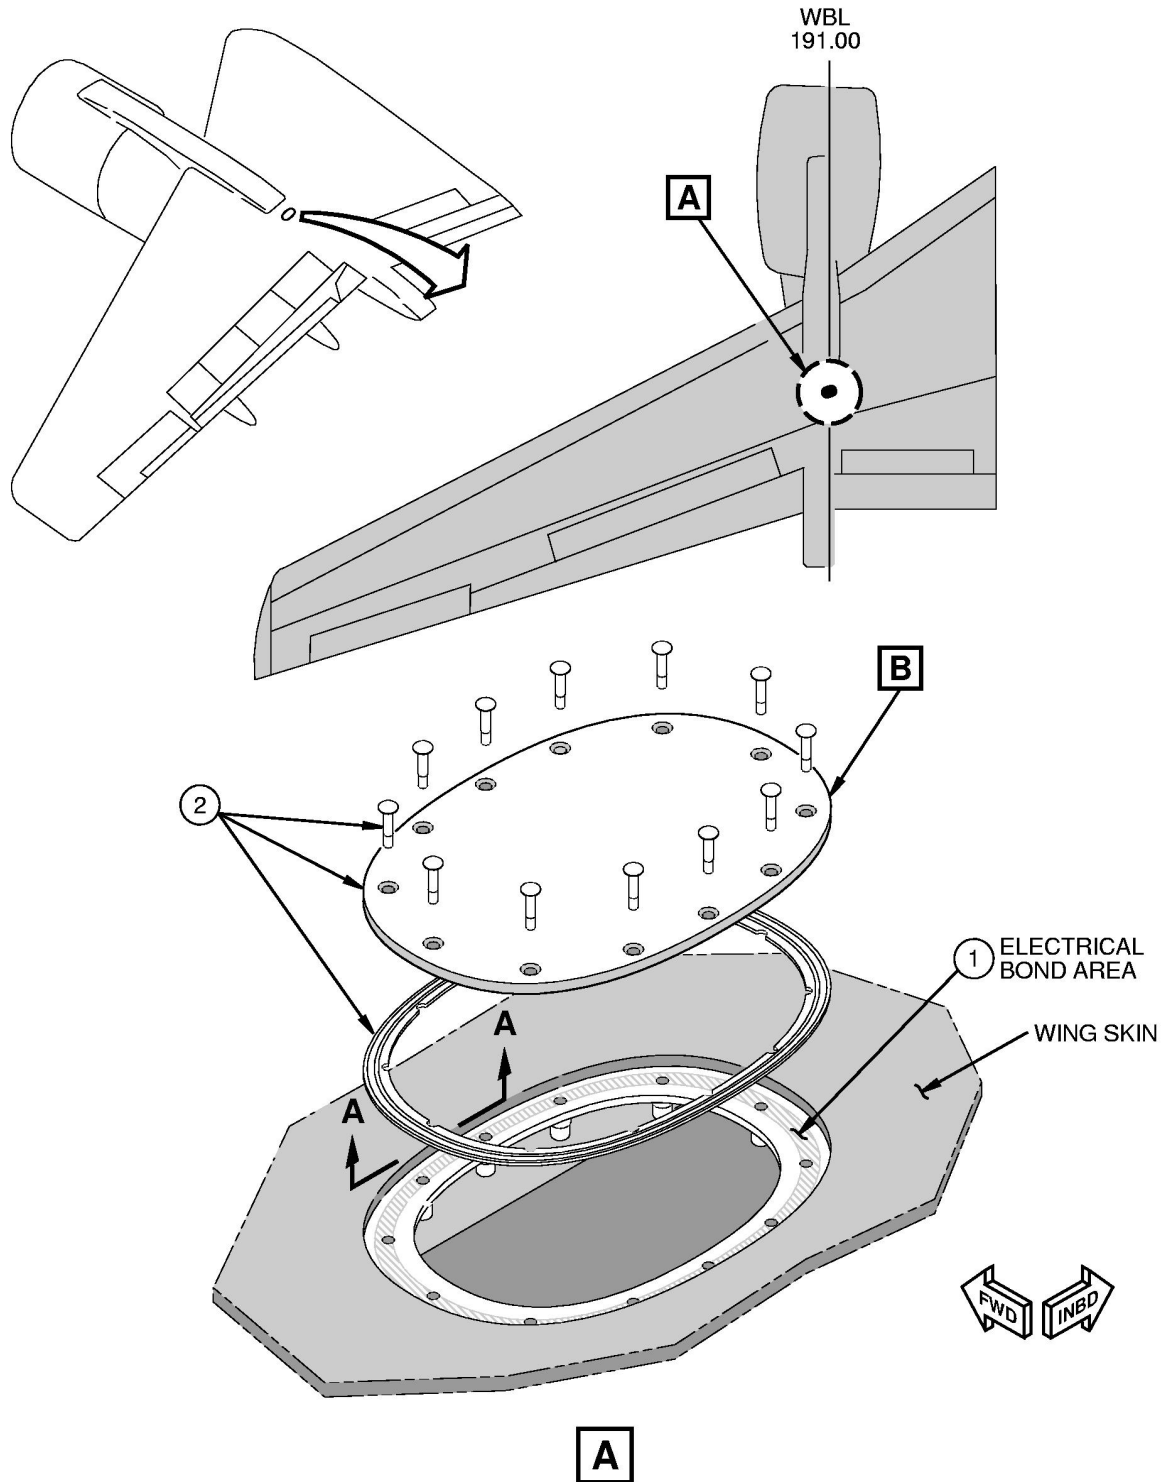
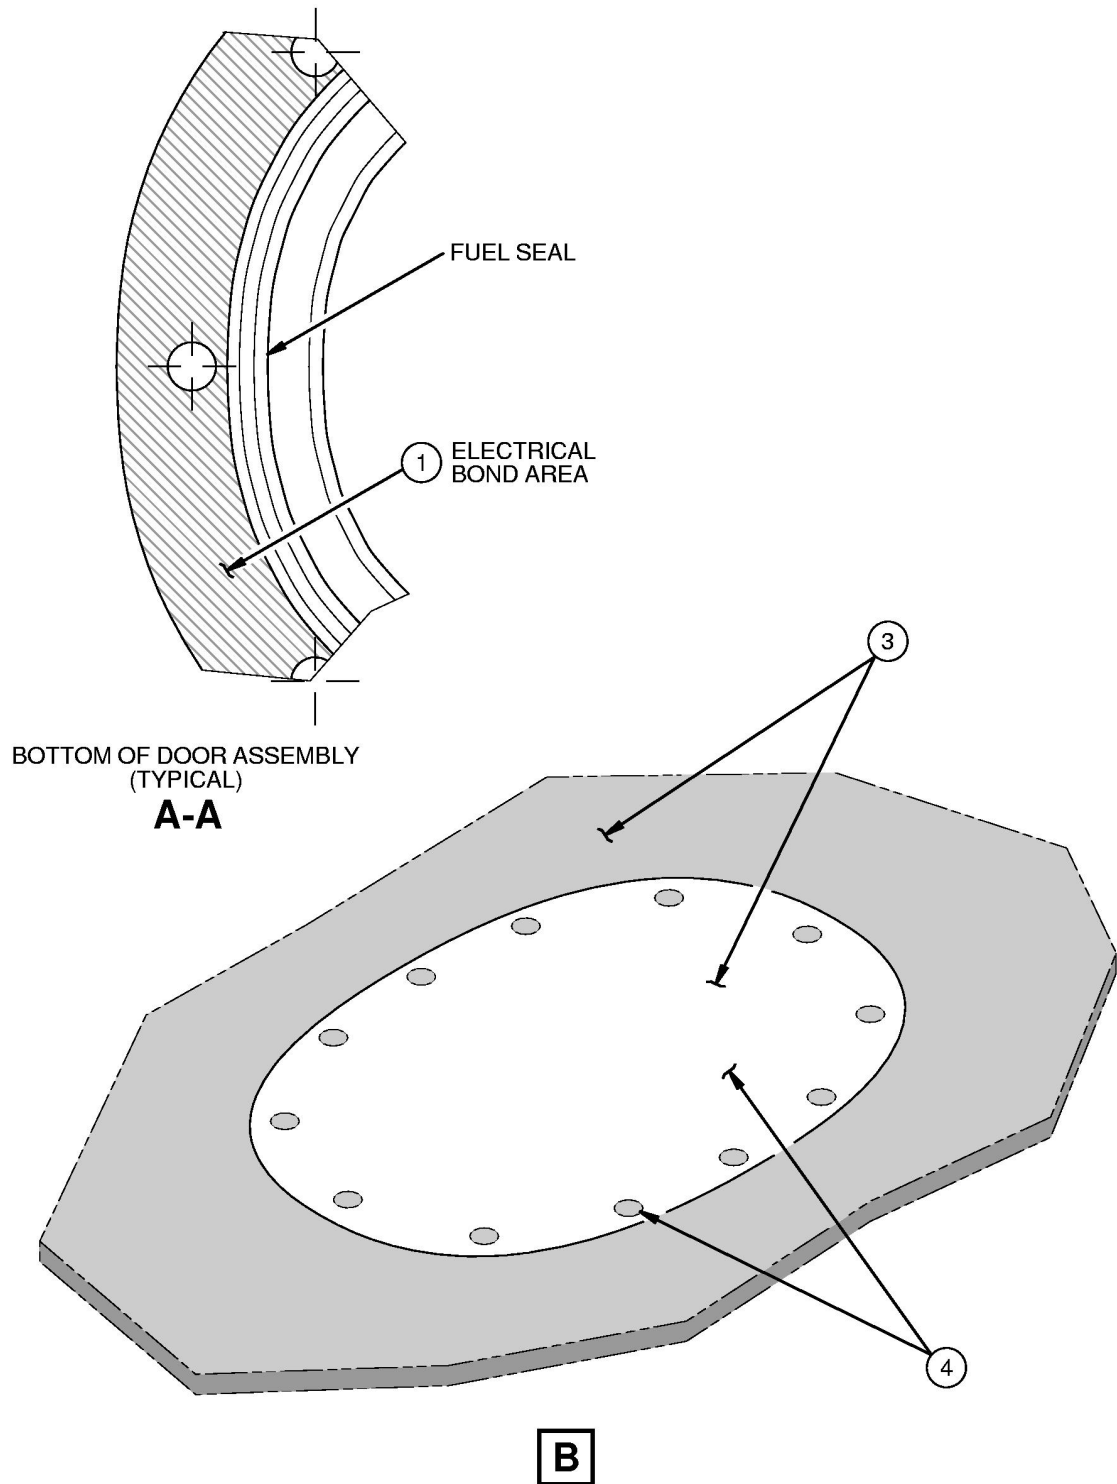
FIGURE 5: LEFT WING - INSTALL NEW DOOR ASSEMBLY AND WIRE MESH GASKET, APPLY ENAMEL FINISH, MEASURE ELECTRICAL BOND (SHEET 1 OF 4)

| Step | Task | Name | Identification | Qty | More Data |
|--|---|--|---|---|--|
| CAUTION: APPLY THE AEROSHELL NO. 14 GREASE CAREFULLY. THIS GREASE CAN CAUSE CONTAMINATION OF THE FUEL TANK. | | | | | |

- a) The electrical bond check is complete if the maximum resistance is 0.0025 ohm (2.5 milliohm) or less.
 - b) If the maximum resistance is NOT 0.0025 ohm (2.5 milliohm) or less, contact Boeing for repair instructions and do the repair.

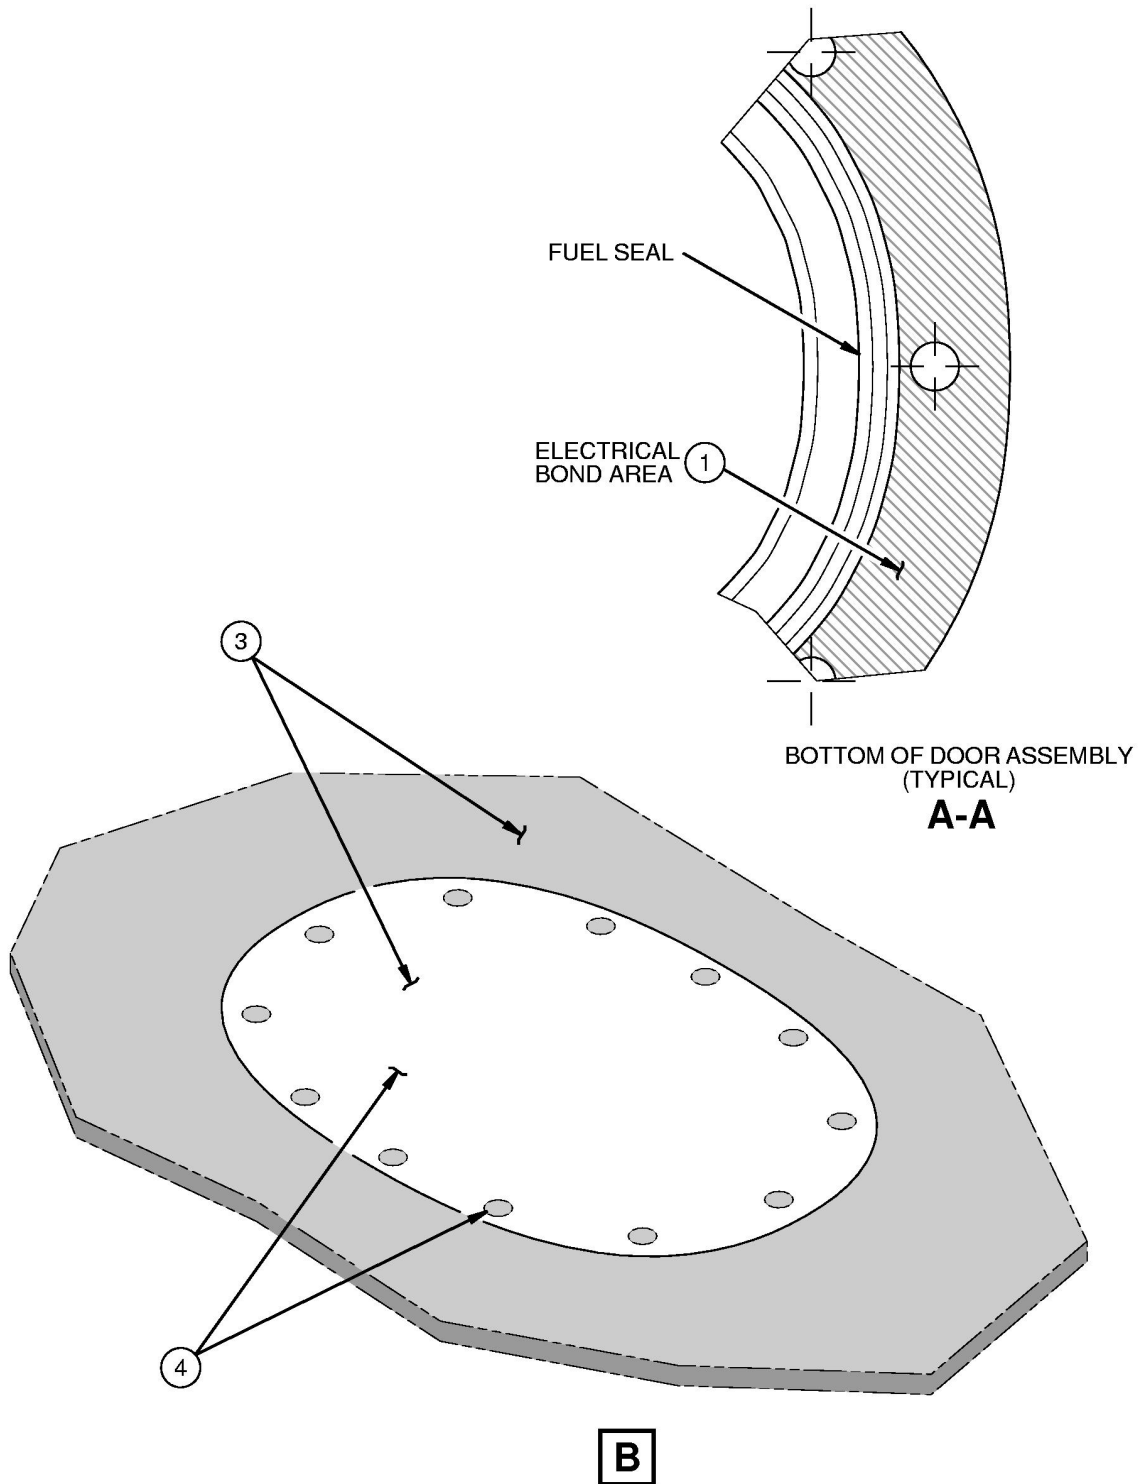
**FIGURE 6: RIGHT WING - INSTALL NEW DOOR ASSEMBLY AND WIRE MESH GASKET, APPLY ENAMEL FINISH, MEASURE ELECTRICAL BOND
(SHEET 2 OF 4)**

| Step | Task | Name | Identification | Qty | More Data |
|--|---|--|---|---|--|
| CAUTION: APPLY THE AEROSHELL NO. 14 GREASE CAREFULLY. THIS GREASE CAN CAUSE CONTAMINATION OF THE FUEL TANK. | | | | | |

- a) The electrical bond check is complete if the maximum resistance is 0.0025 ohm (2.5 milliohm) or less.
 - b) If the maximum resistance is NOT 0.0025 ohm (2.5 milliohm) or less, contact Boeing for repair instructions and do the repair.
